NASA/TM-2005-213750/Version 1.0
NESC-RP-05-18

Space Shuttle Orbiter Reaction Jet Driver (RJD)

Independent Technical Assessment/Inspection (ITA/I) Report

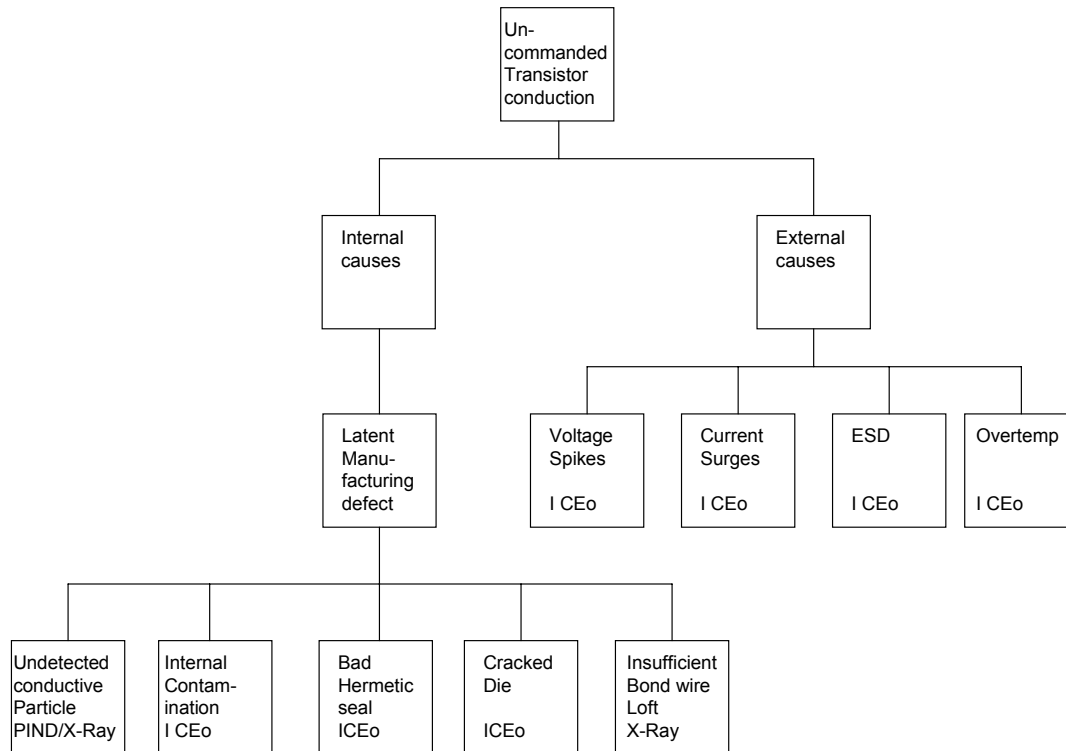
Figure 7.4.2.1-2. Darlington Transistor Failure Mode Tree

The 28 VDC power connects directly to the collectors of Q1 and Q2; there are no other circuit elements or potential current paths. Therefore, all potential failure modes involve a current path inside either transistor package from the collector to the base. The modeling assumed a collector to base resistive path and that the transistors were otherwise operating nominally. Additionally, to determine the threshold leakage current of one transistor, the other transistor leakage current was set to zero. In reality, the leakage current will be additive and thus the individual minimum shorting resistance may be slightly higher. For Q1, a resistive short between the collector and the base of less than 7k Ω will activate the switch. For Q2, a resistive short between the collector and the base of less than 400 Ω will activate the switch. Thus, it does not require a hard short to activate the switch and provide sufficient current to fire the thruster.

Failure modes for the Darlington transistors that could potentially cause thruster firing identified by the NESC are shown in Figure 7.4.2.1-2.

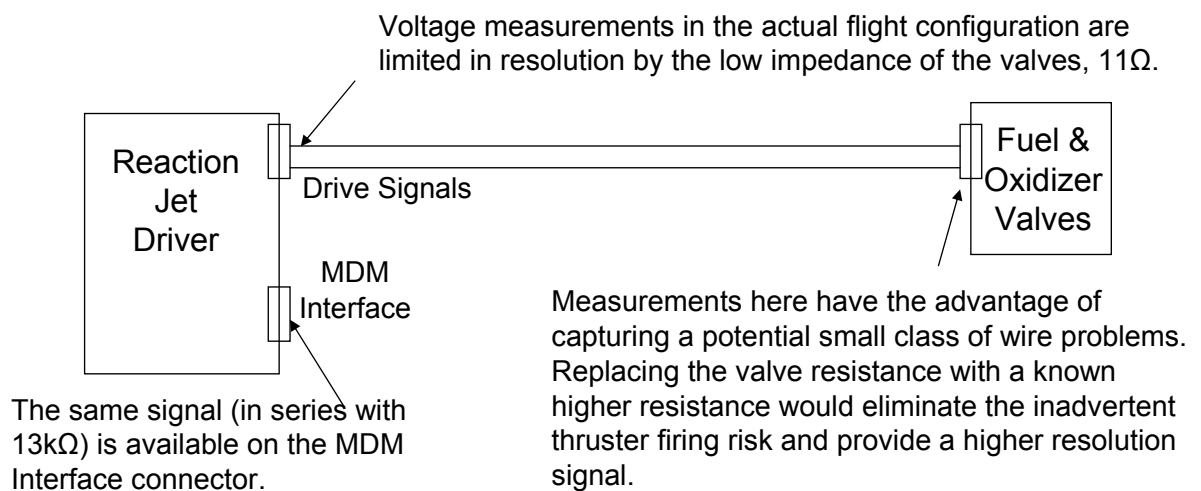
Figure 7.4.2.2-1. Leakage Current Measurement Location Options

The exact leakage current and expected distribution of this parameter to the transistor population has not been calculated. However, it should be in the tens of micro-amp range up to milliamp range prior to the final failure. The procedure would be to power on the RJD, but not to command the thrusters to fire. The test would measure voltage across a known resistance to infer the leakage current. The measurement can be made at three locations: the RJD interface, the MDM interface, or the closest available connector to the actual valves. Each location has advantages and disadvantages, which are described in Figure 7.4.2.2-1.

Since it does not require a hard short of the Darlington transistors to fire the thrusters, the NESC has studied and recommended leakage current testing to measure all Darlington pair leakage currents and to verify that they fall within an acceptable distribution. Any Darlington pair measurement that is not “in-family” should be investigated to determine the cause. The data can also be used to trend an individual Darlington pair’s leakage current throughout its lifetime.

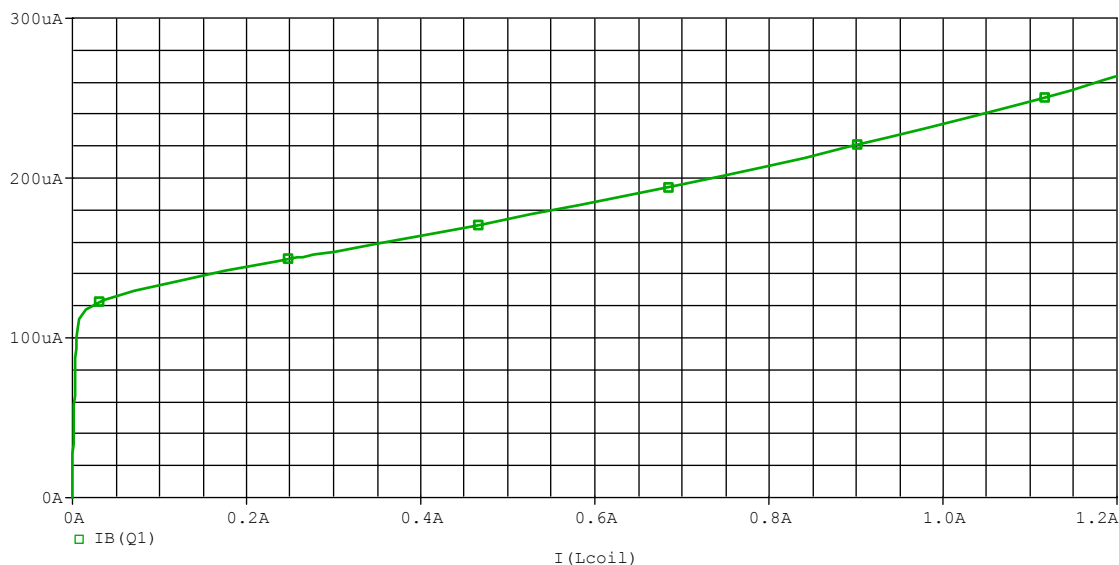
Figure 7.4.2.2-2. Q1 leakage Current vs. Thruster Coil Current

The plot shown in Figure 7.4.2.2-2 indicates the relationship between a potential Q1 (driver transistor) base leakage current and the thruster current. Leakage current from Q2 (output transistor) would have a similar effect only at a different magnitude. The actual box-level measurement will include the base leakage current of Q1 (multiplied by the gain of Q2) plus the base leakage current of Q2.

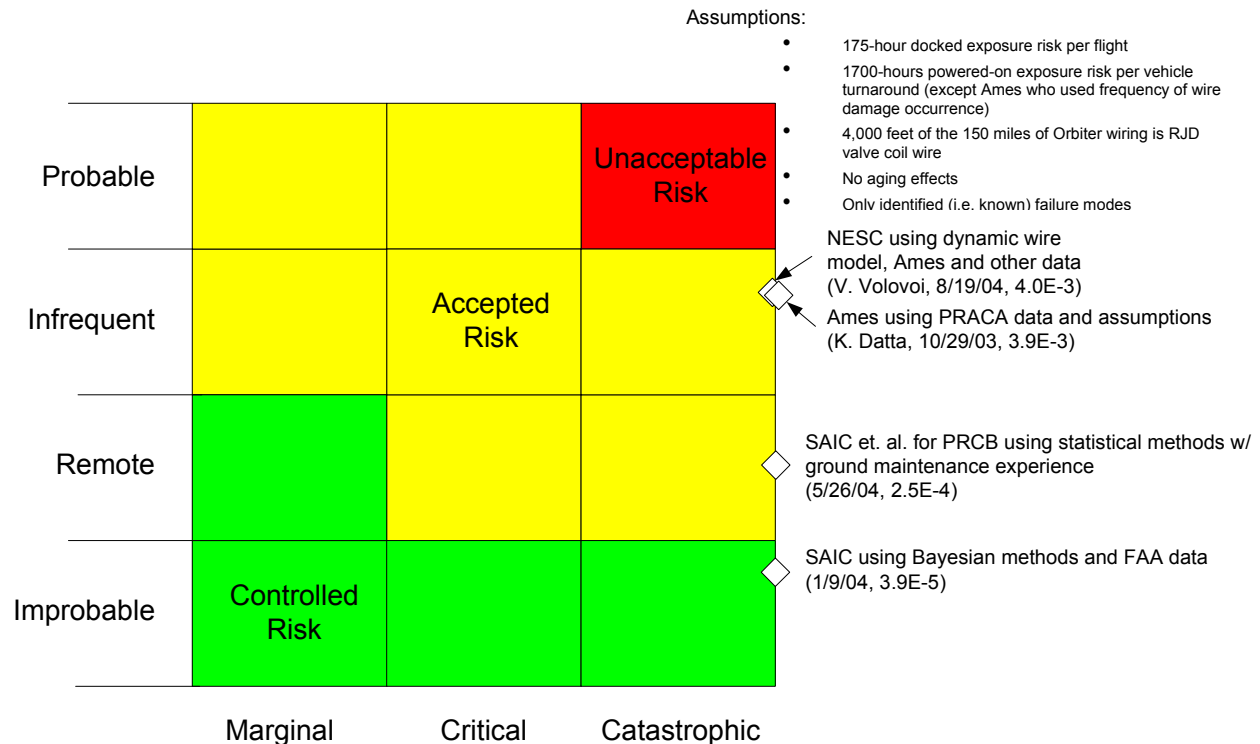
Figure 7.5.1-1. Wire-to-Wire “Smart” Short Aggregated Failure Probability for 28 Flights

1. Using the Program's 4 x 3 Risk Matrix (shown in Figure 6.2-1), the wire-to-wire "smart" short PRA likelihood computed by the NESC is infrequent ($\sim 4 \times 10^{-3}$ for 28 flights or 1.5×10^{-4} per flight). The consequence is catastrophic. See Figure 7.5.1-1. *Note that this numeric result is essentially the same as the least favorable result that the Program had initially considered.*

2. NESC's wire PRA number has high uncertainty because the effects of wire aging and the level of maintenance-induced wire damage presently are unknown.

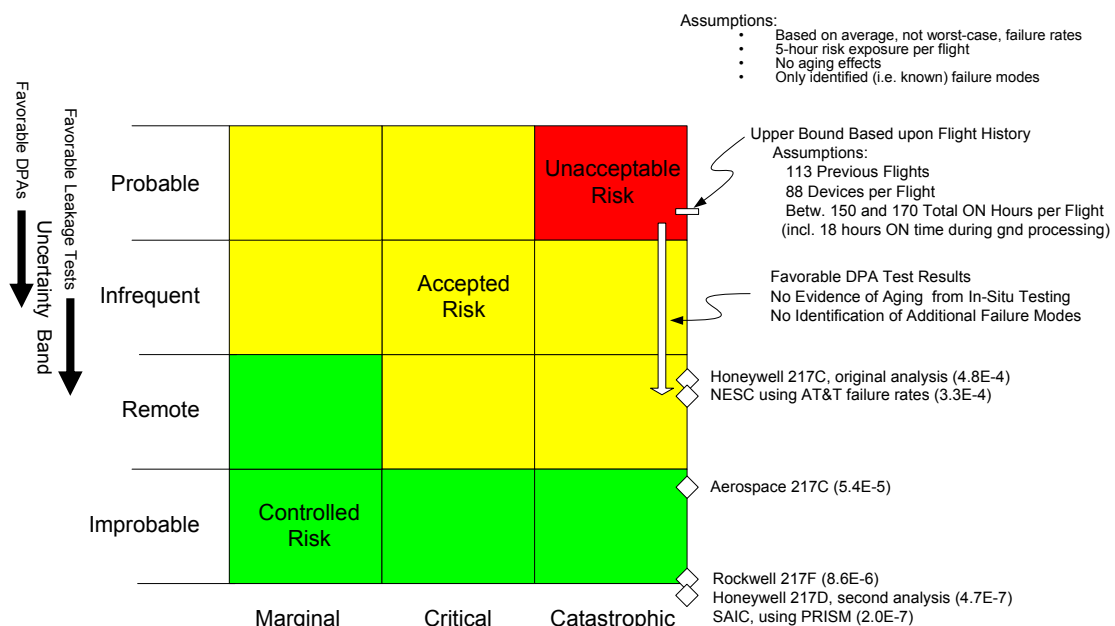
Figure 7.5.2-1. Darlington Transistor Aggregated Failure Probability for 28 Flights

1. Using the Program’s 4 x 3 Risk Matrix, the Darlington PRA likelihood is infrequent ($\sim 3 \times 10^{-4}$ for 28 flights or 1.18×10^{-5} per flight). The consequence is catastrophic. *Note that this numeric result is approximately three orders of magnitude less favorable than the Program’s estimate, and is very close to the Honeywell (RJD original equipment manufacturer) analysis (see Figure 7.5.2-1).*

6. Because of PRA uncertainties and limitations, zero-fault-tolerance of the RJD circuit design, and the potential for undiscovered latent defects or unknown failure modes, the majority of the technical team and slightly more than one half of the NRB recommended redesign of the RJD box to be at least single-fault-tolerant against the dual fault tolerant requirement. This can be accomplished by incorporating high-side and low-side switching. The scope of such a change may possibly be limited to a redesign of the RJD heat sink assemblies and BITE circuit with the use of HEXFET switches, in lieu of bipolar power transistors, as the drive signals are transformer coupled. Such a change would improve the fault tolerance of the RJD box driver switches by approximately a factor of 10^6 and make the design more consistent with normal practice for circuits of such criticality, the penalty being reduction of reliability for normal firing by a factor of two. Note that the electronics are considered to be much more reliable than the valves, and that the probability of a failure to energize a thruster will be dominated by mechanical failure modes of the valve.

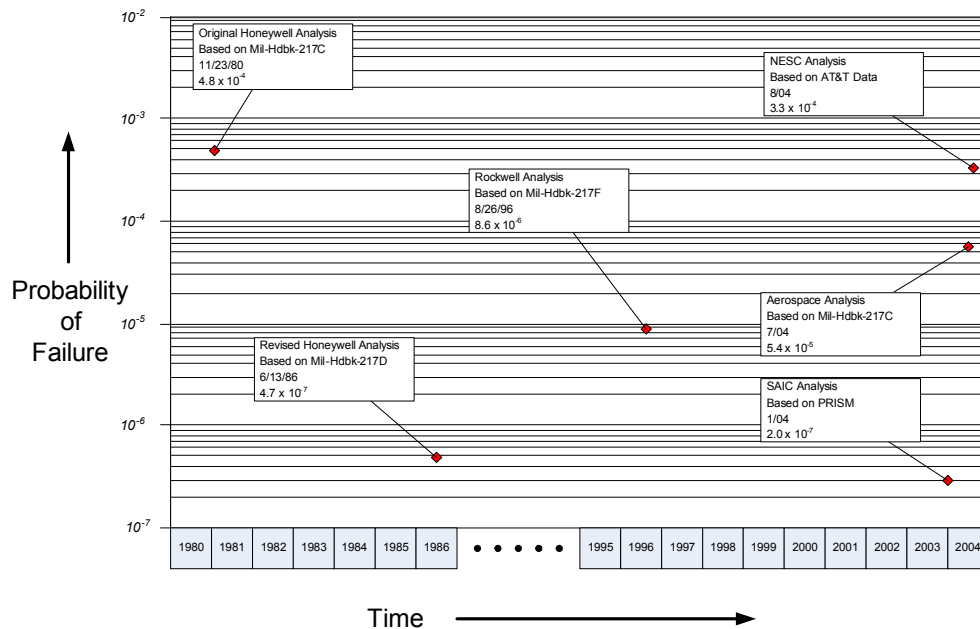
Figure 7.5.2-2. Darlington Transistor Failure Analysis History

3. There are known limitations with both the SSP and NESC Darlington PRAs (i.e., no aging was assumed and the use of PRISM® and MIL-HDBK-217 for in-service failure predictions *is not recommended*). Darlington failure by analyses has estimates that vary by approximately three orders of magnitude over the life of the program as shown in Figure 7.5.2-2.

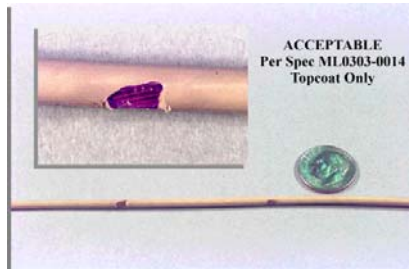
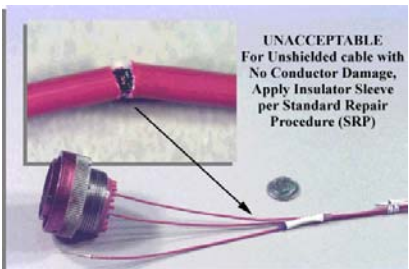
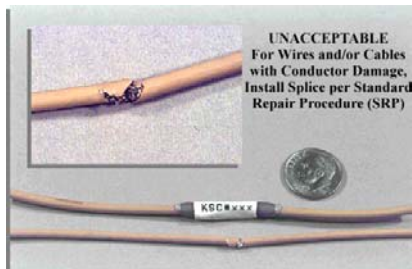
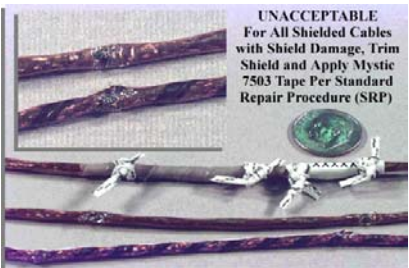
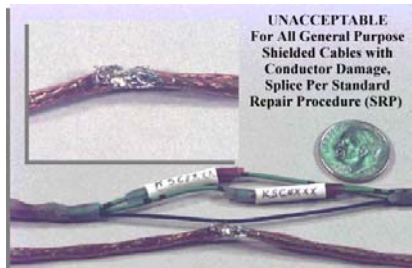
Source: Orbiter Wiring Discrepancy & Repair, Course Presentation, 4/21/00, Boeing

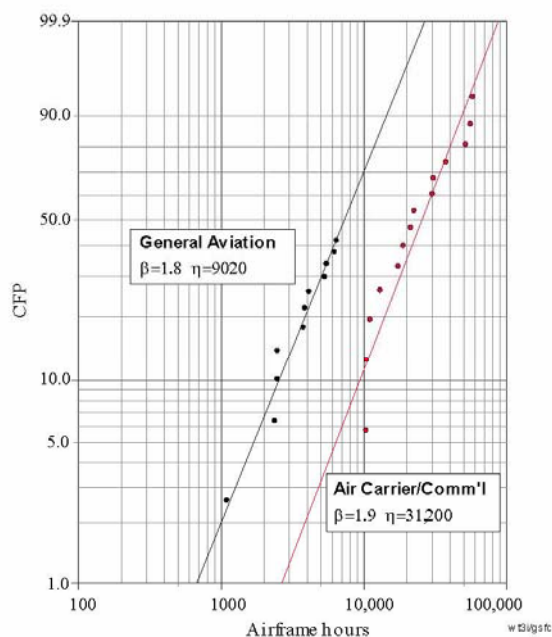
incidents are occurring more frequently as aircraft accumulate operating hours. The identical slopes imply failures occurred with similar modes (failure mechanisms). Characteristic lives (“ η ”) were 9020 and 31,200 airframe hours, respectively. The behavior of characteristic lives is very interesting. Generally, AC/C aircraft accrue considerably more operating hours per calendar year than GA aircraft. Thus, one would expect the AC/C failure distribution to coincide or precede that for GA aircraft. However, the AC/C plot is displaced approximately 20,000 hours *later*. This suggests a causal factor other than aircraft operating hours, when GA and AC/C are compared. (No data were available for aircraft calendar ages at the event times). Nonetheless, these data do show that civil aircraft wiring incidents exhibit an increasing failure rate with time.

Figure G-1. Weibull plot of civil aircraft wiring “incidents”. Data for both GA and AC/C aircraft have the same slope, but are displaced along the time axis.

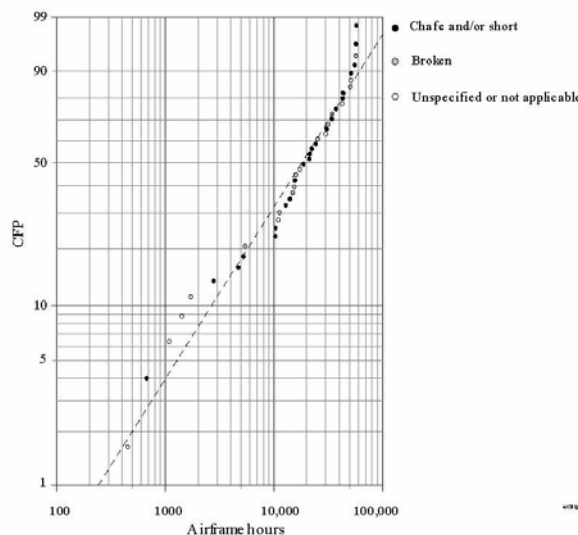
Figure G-2. Weibull plot of Air Carrier and Commercial aircraft wire failure incidents. Apparent Weibull slope (β – the dashed line) is ~ 1 , but data clearly indicates mixture of failure modes (plot is not linear). Failures are coded according to legend in upper right.

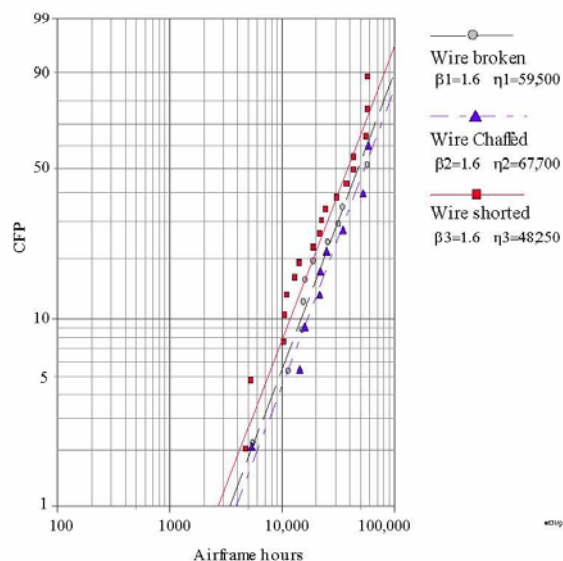
Figure G-3. Weibull plots of Air Carrier and Commercial Operations wiring failure incidents separated by failure modes. The three modes have the same Weibull slopes and are displaced slightly along the time axis. Wiring failures are *not consistent* with a constant failure rate model.

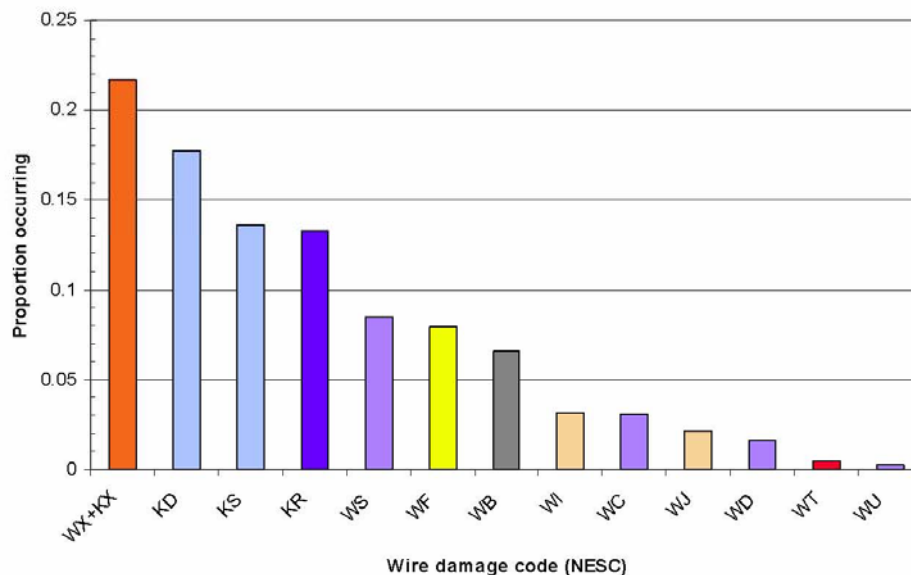
Figure G-4. Pareto chart for OV-103 wiring damage events over the vehicle's lifetime.
(See Table G-III for code descriptions).

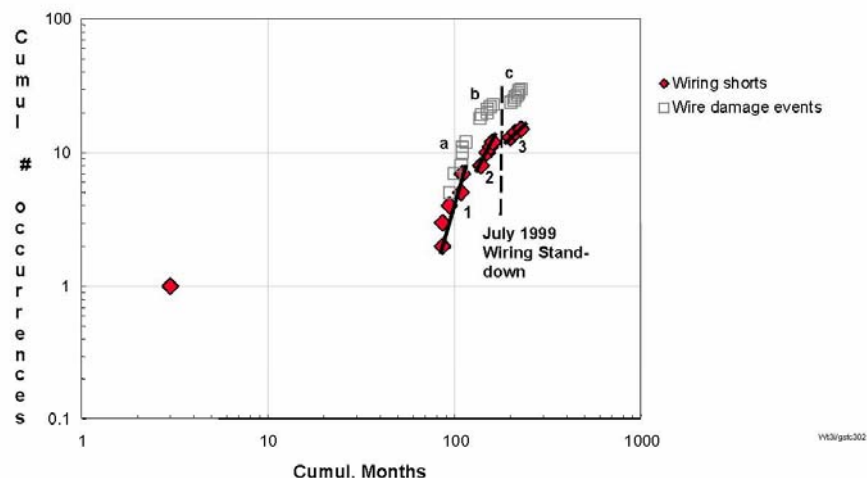
Figure G-5. Crow-AMSAA plot of STS Orbiter Interconnect Short Circuits

The one wiring short circuit to the extreme left on the plot was a significant flight occurrence in March 1983. Other data were "missing" until approximately 86 months later.^{**} The 1983 datum was suspended for the CA statistical analyses.

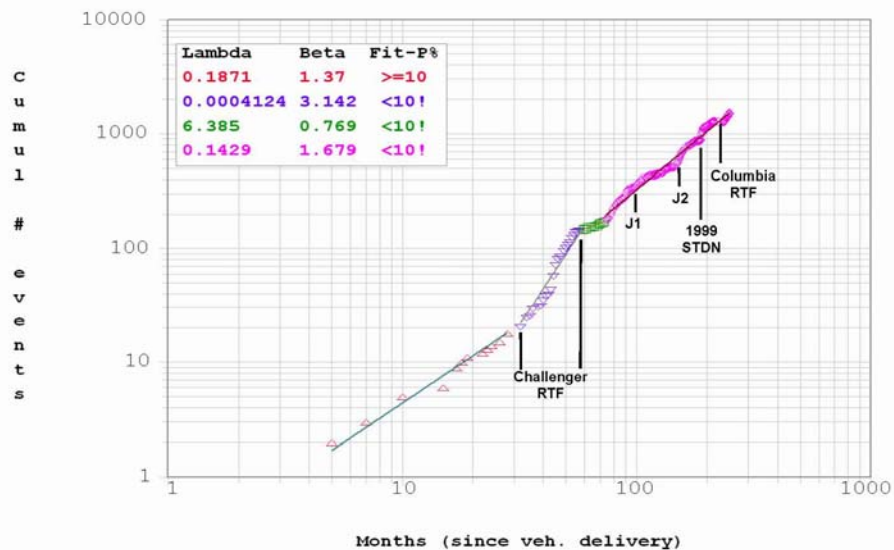
Figure G-6. Crow-AMSAA plot of all detected OV-103 wiring damage events, plotted by months since vehicle delivery

The **Figure G-6** data do not provide a good statistical basis for making any definitive conclusions (because of the poor statistical fit beyond 30 – 40 months).

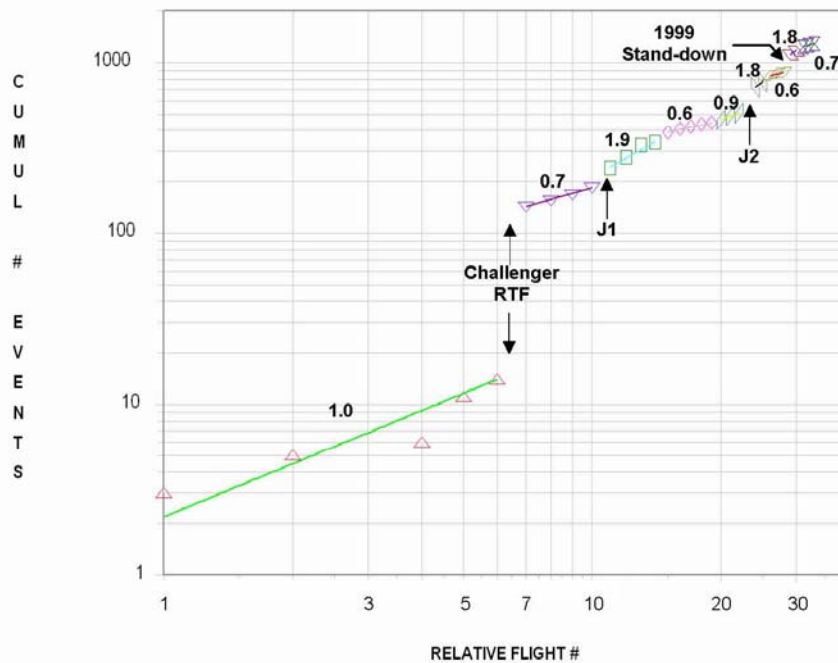
Figure G-7. Crow-AMSAA plot of OV-103 *detected* wiring damage events by vehicle flight number. Numbers above and below lines are slopes. “Relative flight numbers” are vehicle flight numbers incremented by 1 and 2 after J1 and J2, respectively.

In this plot, one can see the jumps at *Challenger* RTF, J1, J2, and the 1999 stand-down. Post-*Columbia*-accident data was not plotted. The initial (up to *Challenger*) detection rate was static (slope ~ 1), compared to the 1.4 seen in the “by month” data. After *Challenger* RTF, the per-flight data exhibited the same slope of decreased wire damage detection (0.7 vs. 0.8 for the “by month” data) until the J1 OMM activity. After J1, detected events increased for four flights and then decreased for the next five flights (0.6 slope). There was an increase in detected events for flights 19 through 21. An expected jump occurred for J2 OMM. Then detected events changed between increased detection (slope 1.8) and decreased detection (slope 0.6) until the 1999 stand-down. It subsequently followed the same pattern after the 1999 stand-down – increased detection (1.8) then reduced detection (0.7). The inspection/detection process appears to oscillate between enhanced and diminished detection since the J1 OMM activity.

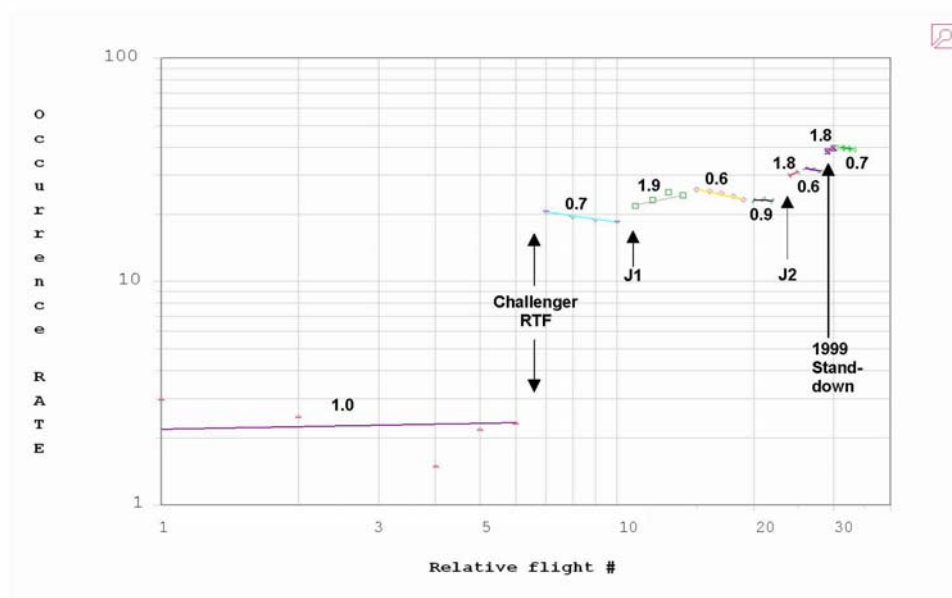
Figure G-8. OV-103 Wiring Damage Events (By Flight Cycle) Plotted as Occurrence Rates, from CA Plot

The **Figure G-8** data are the event occurrence *rates* (analogous to failure rates) plotted per (cumulative) flight cycle. For this presentation, a “flat” line means the process is static (not changing with time), an upward slope (to the right) means events are occurring more frequently with time (more events detected per flight cycle), and a downward slope means fewer events occurring with time (fewer detected per flight cycle). This plot reflects the same trends shown in the “traditional” CA plot (**Figure G-7**) and it is easier to distinguish between “improvement” and “deterioration”.

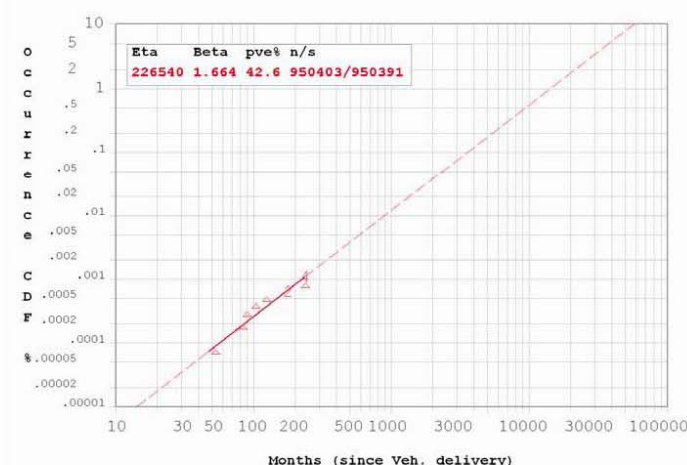
Figure G- 9. Weibull plot of OV-103 wiring short-circuit events. The Weibull slope indicates early wear-out failures are occurring.

The Weibull parameters ($\beta = 1.7$ and $\eta = 226,500$ months) indicate an early wear-out failure mode, that is, the failure rate is increasing with time, albeit at a slower rate than “true” wear-out (β greater than 4). Thus for wire short circuits, there *is* an effect in that the failure (or occurrence) rate is increasing with time. The above Weibull parameters can be inserted into the fault tree model to replace the existing CFR assumption; this will more accurately reflect wire short circuit occurrences, at least for OV-103.

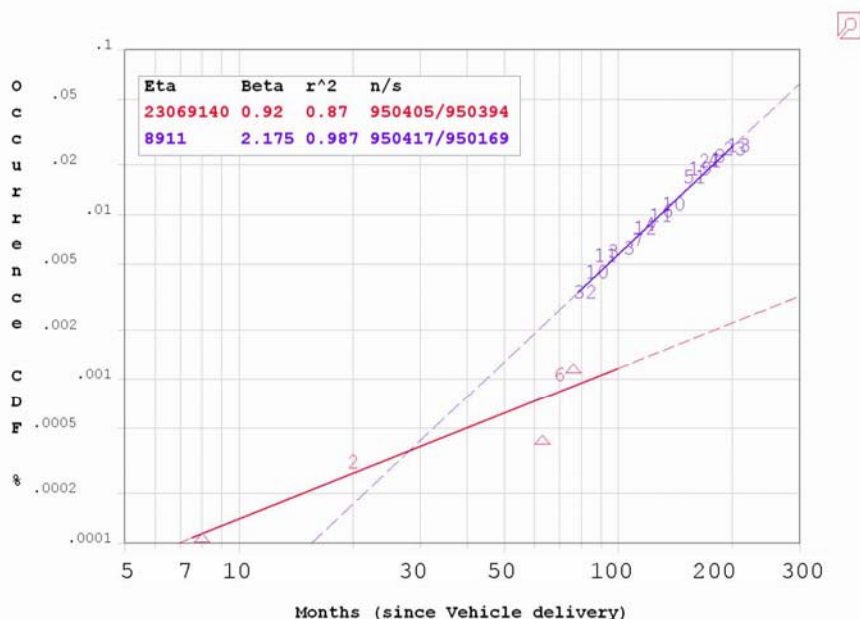
The resulting K-M Weibull fit was excellent, yielding **Figure G-10**. Exposed conductors initially fail as a near-CFR distribution ($\beta = 0.9$) until about 78 months (six and a half years) when early wear-out failures ($\beta = 2.2$) “take over”. [Exact parameters from the plot can be used in the fault tree calculations or other predictions].

Figure G-10. Weibull plot of Kaplan-Meier data for OV-103 exposed conductor events. Earlier distribution is a near-random failure rate; later distribution is early wear-out.

Exposed conductors are a primary concern regarding the wiring contributions to inadvertent RJD firing. If the Program replaces RJD control wiring (as proposed in the NESC briefings), only randomly occurring exposed conductor failures would be expected for approximately six and a half years of vehicle life after the wiring is replaced. (This assumes that the replaced wiring is equivalent to the existing wiring in the vehicle).

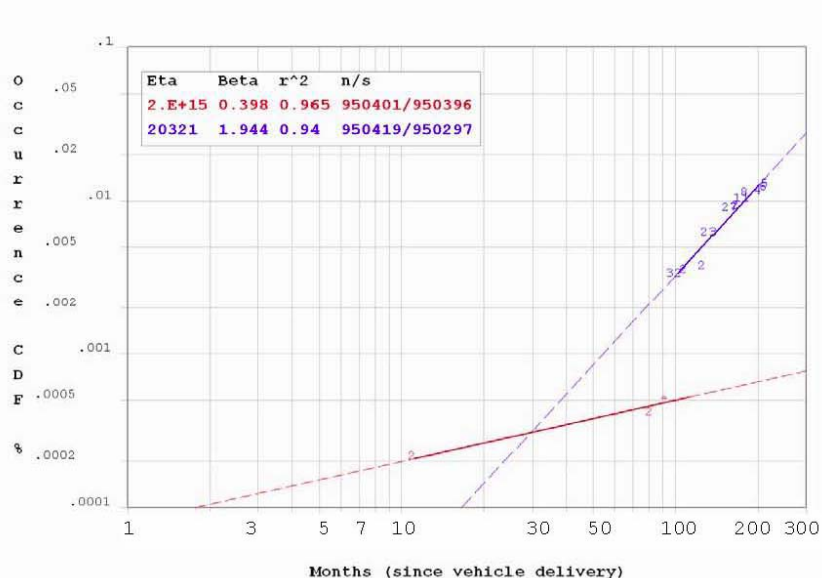
Data for Kapton™ cracks and “ring” cracks (KR code) were analyzed using the K-M function (see **B**, above). The first analysis, using all data as one set gave a poor fit ($r^2 = 0.74$). However, the data pattern was similar to exposed conductors, above. There was an initial “flat”

distribution ($\beta = 0.4$ $\eta = 2 \times 10^{15}$ months) out to about 91 months followed by an early wear-out distribution ($\beta = 1.9$ $\eta = 23,320$ months). The Weibull plot is shown as **Figure G-11**.

Figure G-11. Weibull plot (K-M) for OV-103 Kapton™ cracking and ring cracks.
Early failures are infant mortals; later are early wear-outs.

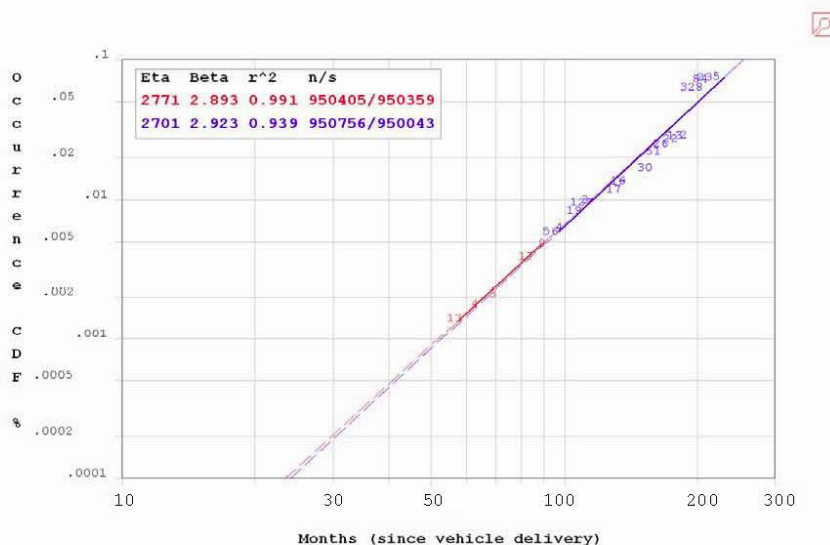
The plot using the “separated” data is shown as **Figure G-12**. In this case, there was no initial “flat” distribution – early wear-out events commenced at about 60 months.

Figure G-12. Weibull Plot of Other Kapton™ Damage Events (KD and KS)

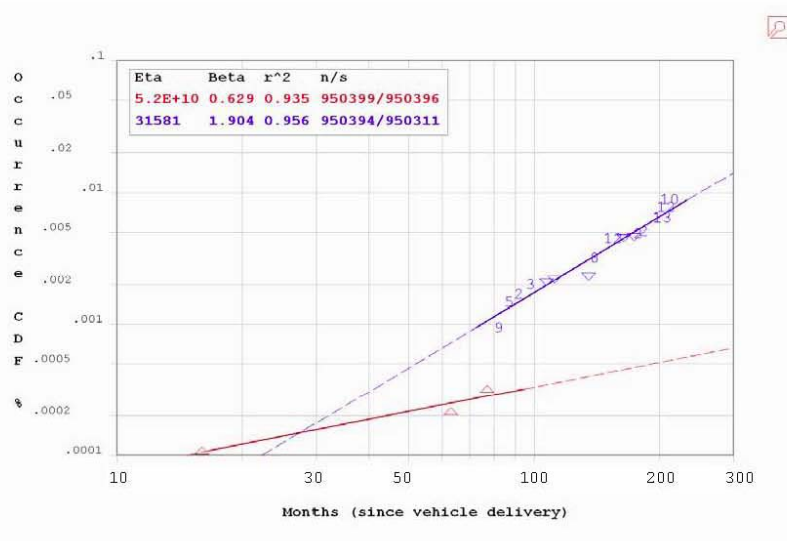
Figure G-13. Weibull (K-M) Plot of Wire Chaffing Events

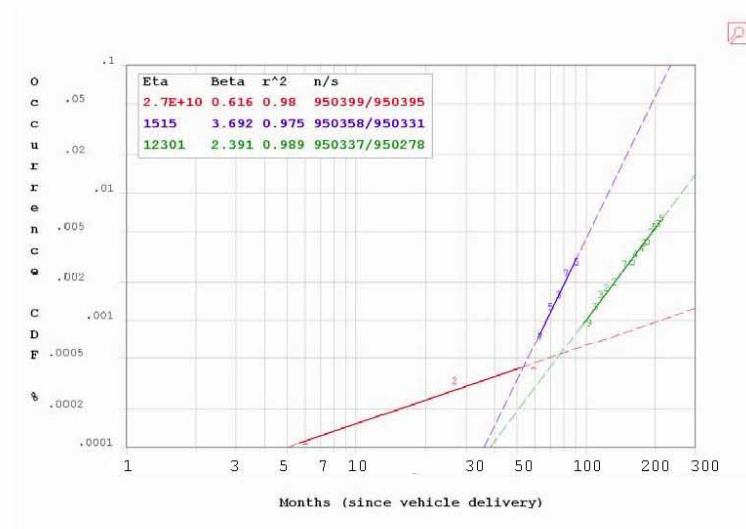
Figure G-14. Weibull (K-M) Plot of Broken Wire Events
